River City Inspection LLC

SUMMARY REPORT

Client: Elaine Blyzes
Inspection Address: 503 Red Baron Dr, Shreveport, LA 71115
Inspection Date: 10/5/2015 Start: 9:00 am End: 11:00 am
Inspected by: Edward Griffith

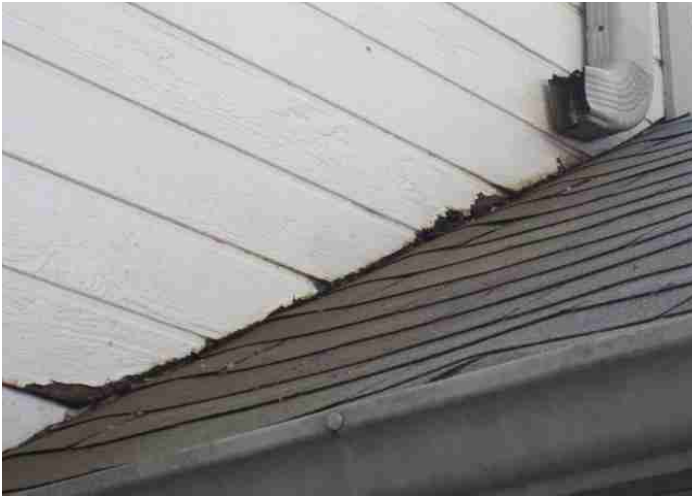
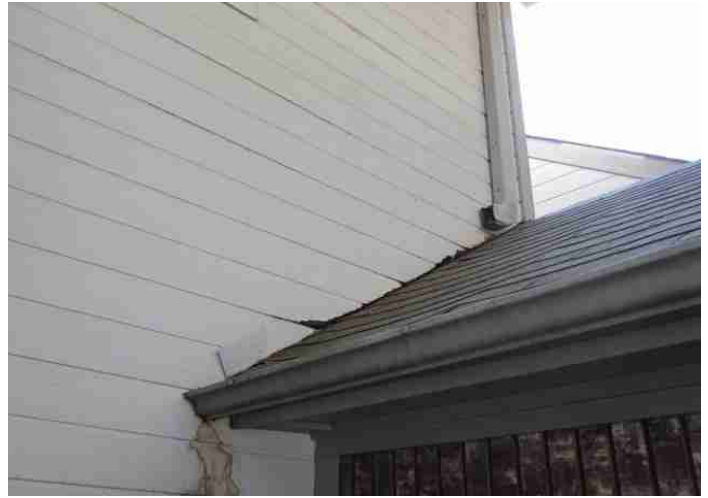
- There are sections of the siding in need of repair. These are primarily located along the bottom of the siding. The photos are representative of the damage but we may not show all of the areas needing repairs.

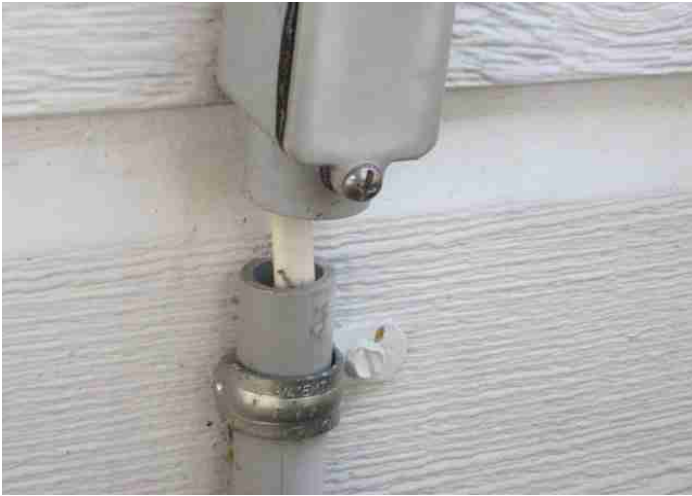
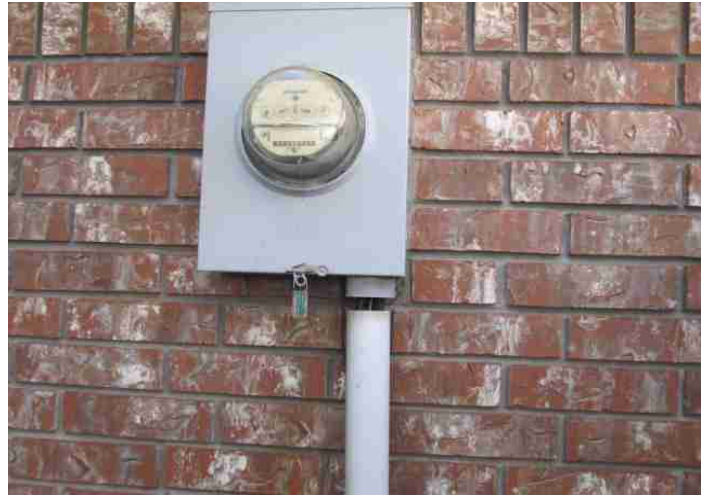
- There is an electrical wire in the side yard that is not encased in conduit.

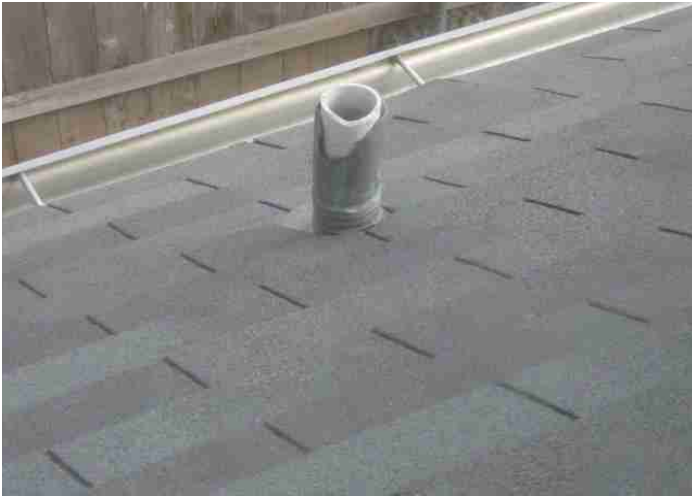
- Several of the lead plumbing flashing's on the roof are deteriorated and should be replaced by a licensed roofing contractor to prevent leaks.

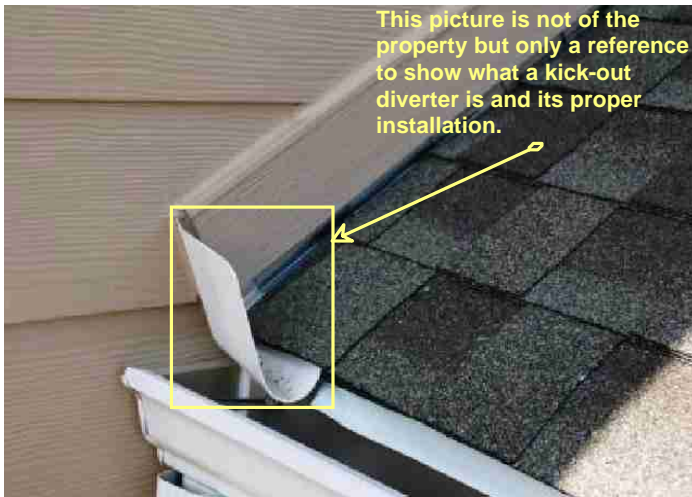
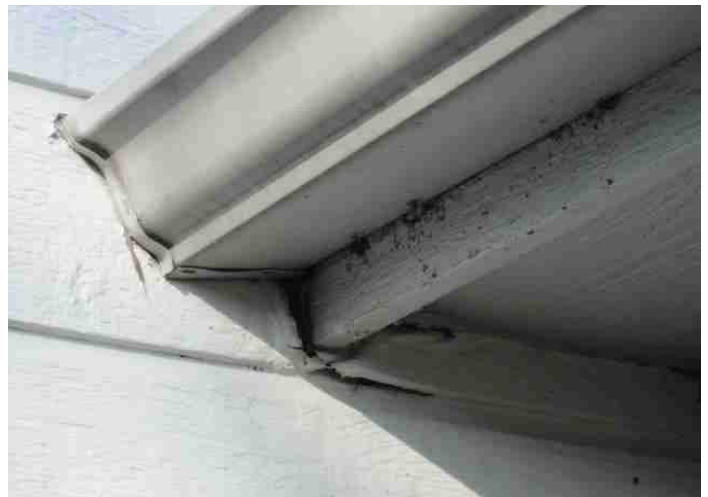
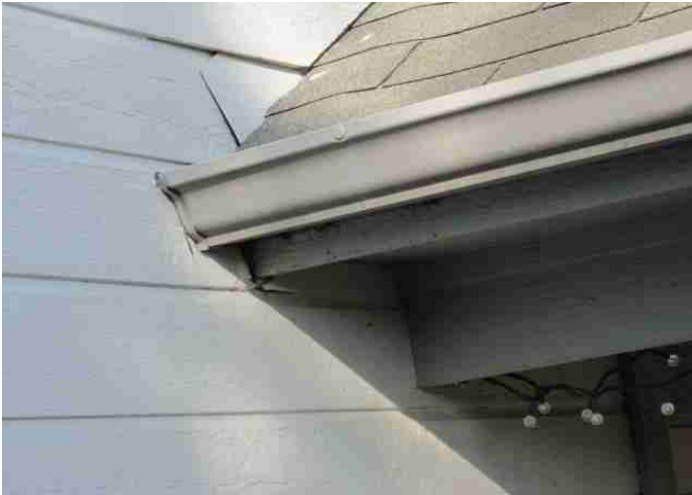
- The gutters need to be cleaned and serviced to drain properly.
- In homes where gutters die into the side wall of a home, there is the potential for moisture issues. Problems arise when rain runs down the roof along the side of the wall and into the gutter. If the water is not purposely directed into the gutter, water may seep between the gutter end cap and the wall. Often the siding is notched in this area leaving a small gap where water can make its way into the interior of the wall. To prevent this, a small piece of "L" shaped metal, called kick-out or diverter flashing is installed. This flashing slips under the wall flashing and then is angled out to direct water into the gutter instead of down the wall where it could possibly penetrate into your home and cause unseen moisture damage. The picture here shows what a typical piece of properly installed diverter flashing looks like.

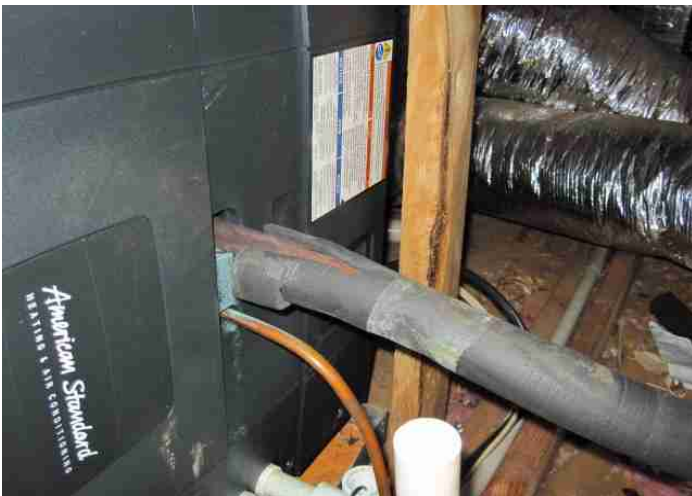
- Insulation is missing from the refrigerant lines at the evaporator coil, which will allow condensation to form and drip, and should be installed.

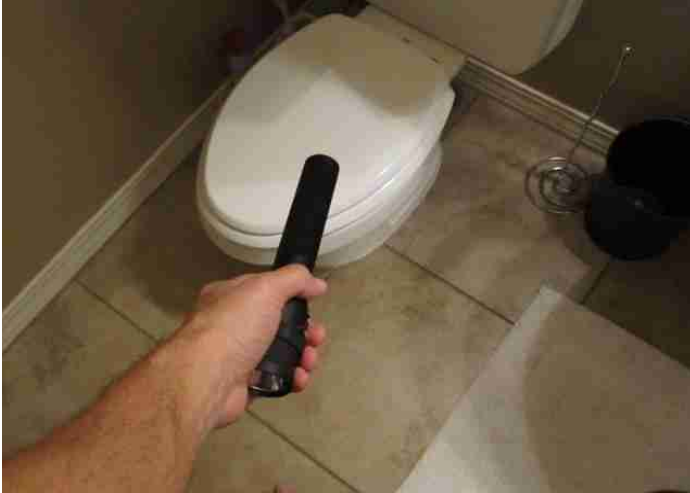
- The toilet is loose, and should be secured by a licensed plumber. This toilet is installed on a ceramic tile floor and likely only needs to be shimmed and caulked. I recommend service by a qualified, licensed and independent plumber.

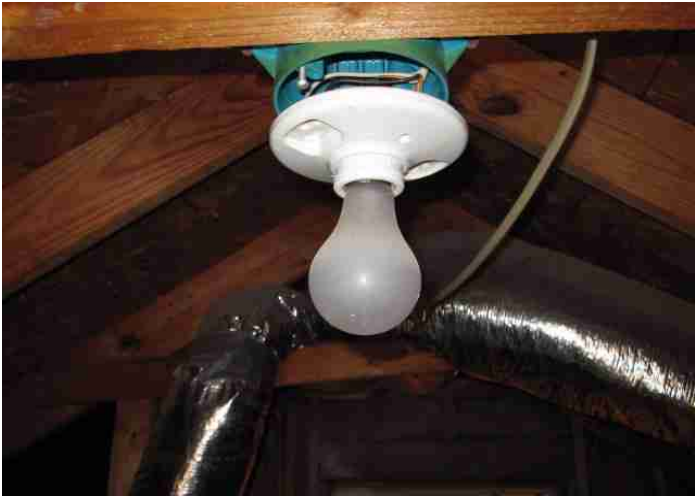
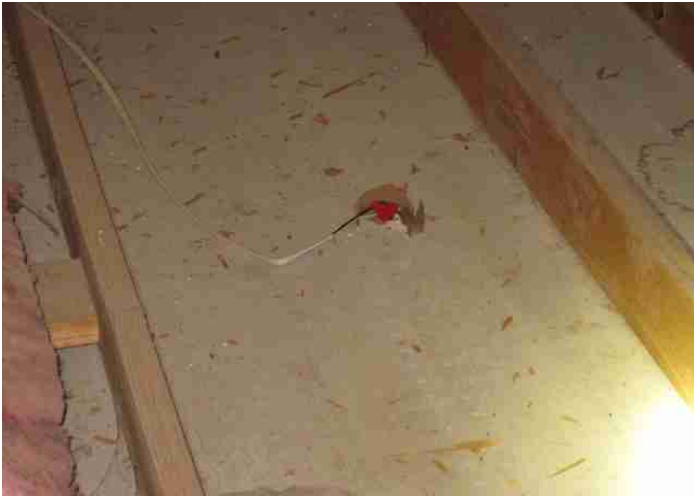
- There is an open electrical junction box, which should be sealed so that any arcing or sparking would be contained within the box.
